**DEPARTMENT OF TRANSPORTATION**

Contract #: 04-0120F4Cty: SF/ALA Rte: 80 PM: 13.2/13.9File #: 69.28**WELDING INSPECTION REPORT****Resident Engineer:**Pursell, Gary**Address:** 333 Burma Road**City:** Oakland, CA 94607**Report No:** WIR-016495**Date Inspected:** 17-Aug-2010**Project Name:** SAS Superstructure**OSM Arrival Time:** 700**Prime Contractor:** American Bridge/Fluor Enterprises, a JV**OSM Departure Time:** 1900**Contractor:** Zhenhua Port Machinery Company, Ltd (ZPMC), Changxing Island **Location:** Shanghai, China**CWI Name:** Qiu Wen**CWI Present:** Yes No**Inspected CWI report:** Yes No N/A**Rod Oven in Use:** Yes No N/A**Electrode to specification:** Yes No N/A**Weld Procedures Followed:** Yes No N/A**Qualified Welders:** Yes No N/A**Verified Joint Fit-up:** Yes No N/A**Approved Drawings:** Yes No N/A**Approved WPS:** Yes No N/A**Delayed / Cancelled:** Yes No N/A**Bridge No:** 34-0006**Component:** Tower & OBG Components**Summary of Items Observed:**

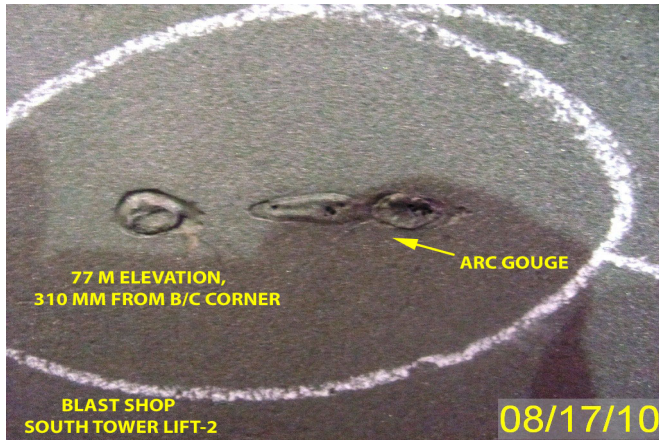
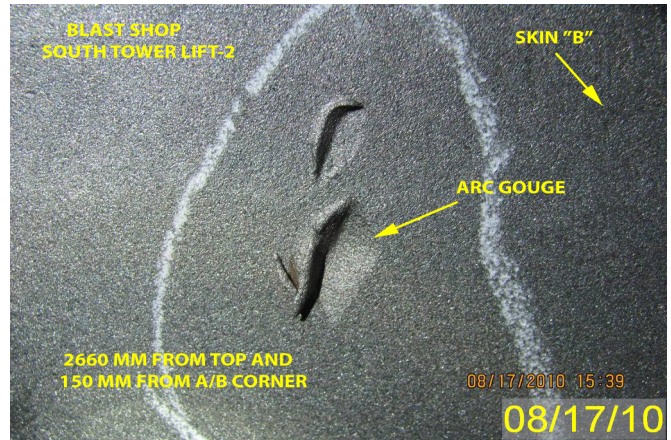
During the External pre-blast visual inspection on South tower Lift-2, these Quality Assurance Inspector's (QA) discovered the defects required welding and Magnetic particle testing on weld and base material at the following locations:

- 1) Skin 'B' – Arc Gouge –2660 mm from top and 150 mm from A/B corner.
- 2) Skin 'B' – Arc Gouge –77 meter elevation, 310 mm from B/C corner.
- 3) Skin 'C' – Arc Strike – 2.5 meter from top and 1010 mm from B/C corner.
- 4) Skin 'C' – Arc Strike – 2.5 meter from top and 1020 mm from B/C corner.
- 5) Skin 'E' – Arc Gouge – 1250 mm from top and 1350 mm from D/E corner.
